SOUHEGAN RIVER WATERSHED  
DAM NO. 26

NH 00207  
NHWRB 234.08

PHASE I INSPECTION REPORT  
NATIONAL DAM INSPECTION PROGRAM

AUGUST 1979

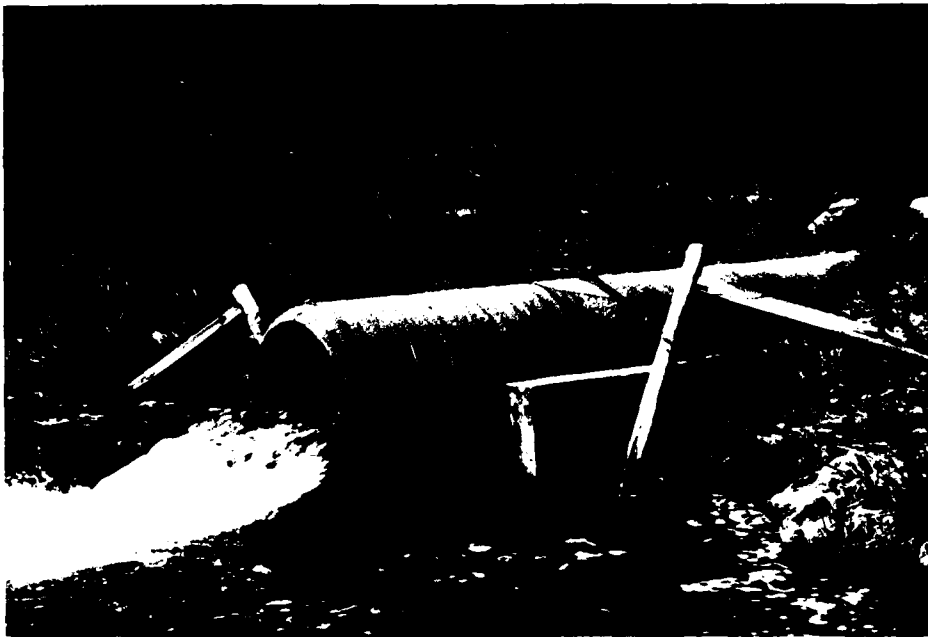
The downstream end of the outlet pipe shows cracking with associated efflorescence over 5 to 10 percent of its exposed surface. These cracks are from shrinkage and lack of quality control during construction. There is no evidence of settlement or displacement of the conduit. The tee bent is completely below ground.

3. View of outlet pipe showing efflorescence and left toe drain outlet

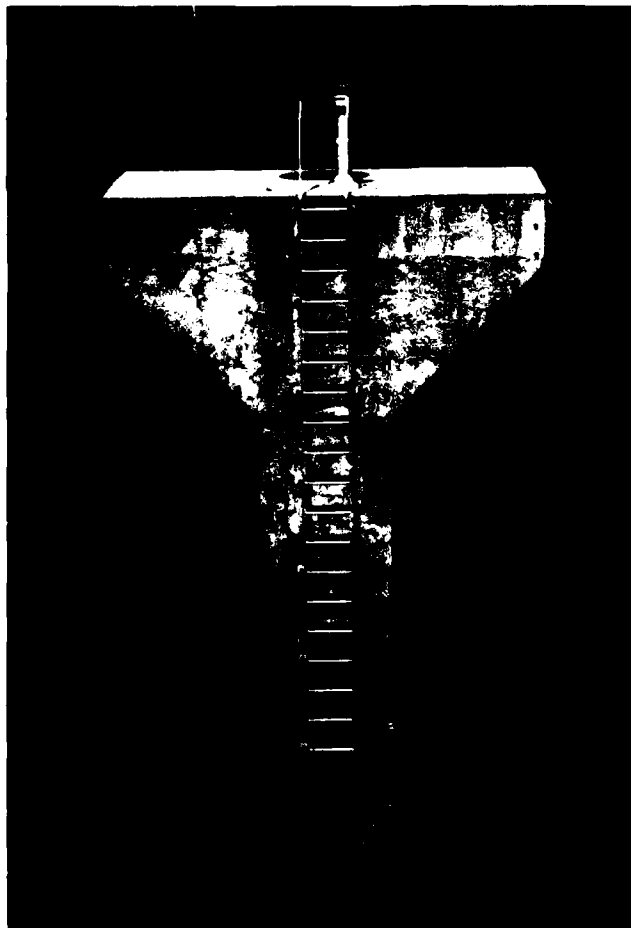
This structure was observed from the embankment since access to the structure was not possible. The existing ladder is too short and no extension was available.

The structure is in good condition with no evidence of spalling, cracking, or efflorescence. The mortar rubbed surface finish has been worn away by moisture intrusion. The sluice gate bench stand is in good condition. The hand wheel has been removed from the site to prevent unauthorized use. The trash racks are in good condition but are clogged with debris. The exterior ladder is too short to allow access to the structure.

4. View of drop inlet structure from embankment

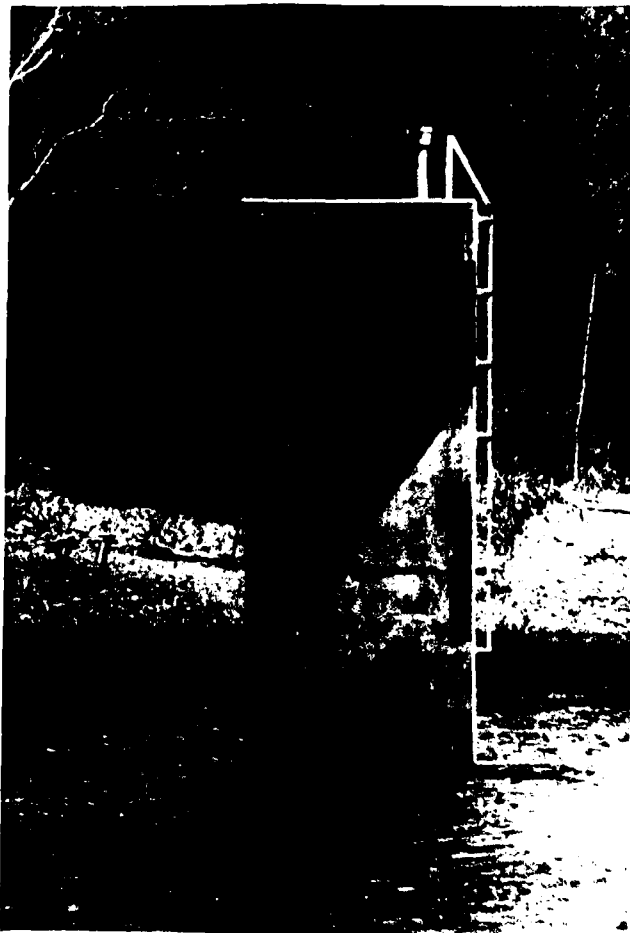
6. View of drop inlet structure showing trash racks
